**NATIONAL  
TRANSPORTATION  
SAFETY  
BOARD**

**AIRCRAFT ACCIDENT REPORT**

CONTINENTAL AIR LINES, INC.,  
McDONNELL-DOUGLAS DC-10-10, N68045  
LOS ANGELES, CALIFORNIA  
MARCH 1, 1978

AAR-79-1

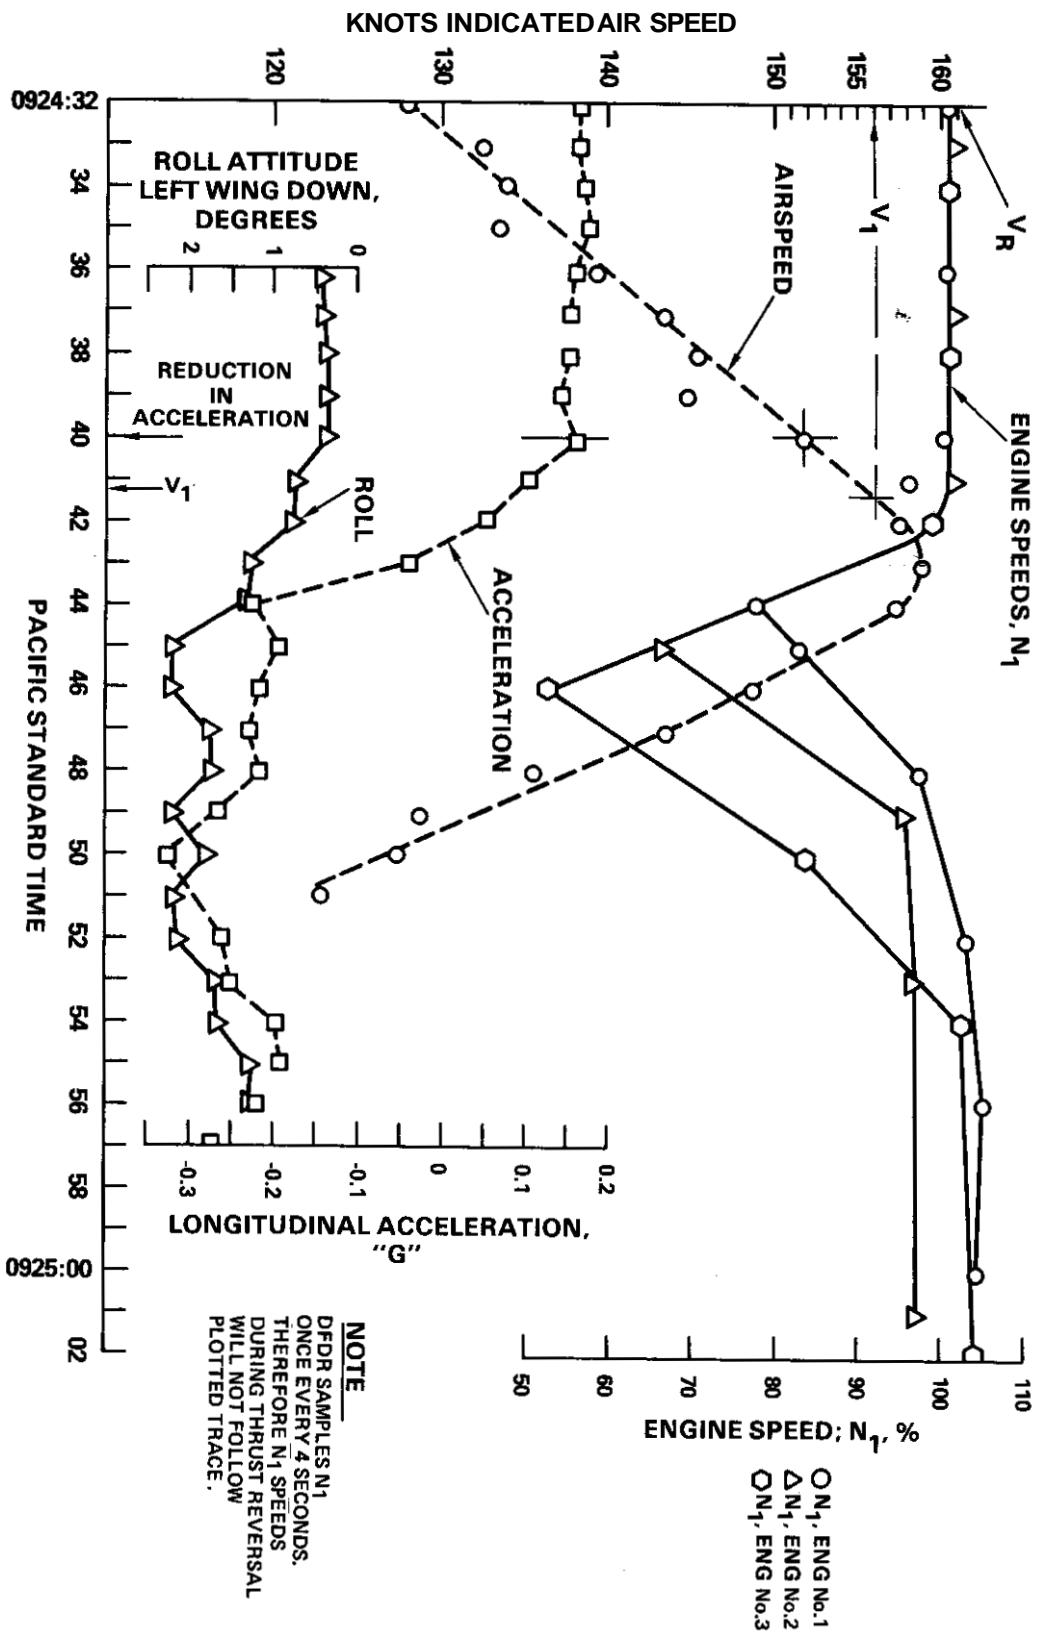
Figure 2. Aircraft performance before, after RTO initiation.

The DFDR data showed that the takeoff roll began from a static position on runway 6R at 0923:54. (See figure 2.) The wing flaps were set at 5°. Takeoff thrust was established at 101-percent  $N_1$  on all engines as the aircraft accelerated through 37 kns. At 152 kns, 46 sec into the takeoff roll and 4 kns below  $V_1$ , the longitudinal accelerometer began recording a marked decrease in the aircraft's acceleration although takeoff thrust was being maintained on all engines. No indications of tire failure were evidenced below 152 kns by the DFDR. At 152 kns, the DFDR roll attitude parameter began to record a gradual lowering of the left wing.  $V_1$  speed, 156 kns, was reached 1.2 sec later, or 47.2 sec after the start of the takeoff roll. Engine thrust began to be reduced less than 0.5 sec after  $V_1$  speed. A maximum speed of 159 kns, 2 kns below  $V_R$ , was recorded 1.8 sec after  $V_1$  and 0.5 sec after longitudinal acceleration had changed from positive (acceleration) to negative (deceleration) values. Thrust reversers unlocked while the airspeed was decelerating through 157 kns at a peak deceleration rate of  $-0.23g$ . About 1.2 sec later, the thrust reversers were deployed at 152 kns as the engines were spooling down for thrust reversal and as the left wing reached its maximum down attitude of 2.1'. The engines began to spool up for thrust reversal 4.8 sec after  $V_1$ ; maximum reverse thrust values were attained in 3 sec on the center engine, in 6 sec on the left engine, and in 8 sec on the right engine. Aircraft heading began to deviate to the right of the runway centerline as full reverse thrust was being attained. The heading reached 079°, the maximum deviation from the centerline, as the aircraft's speed decelerated through 58 kns.

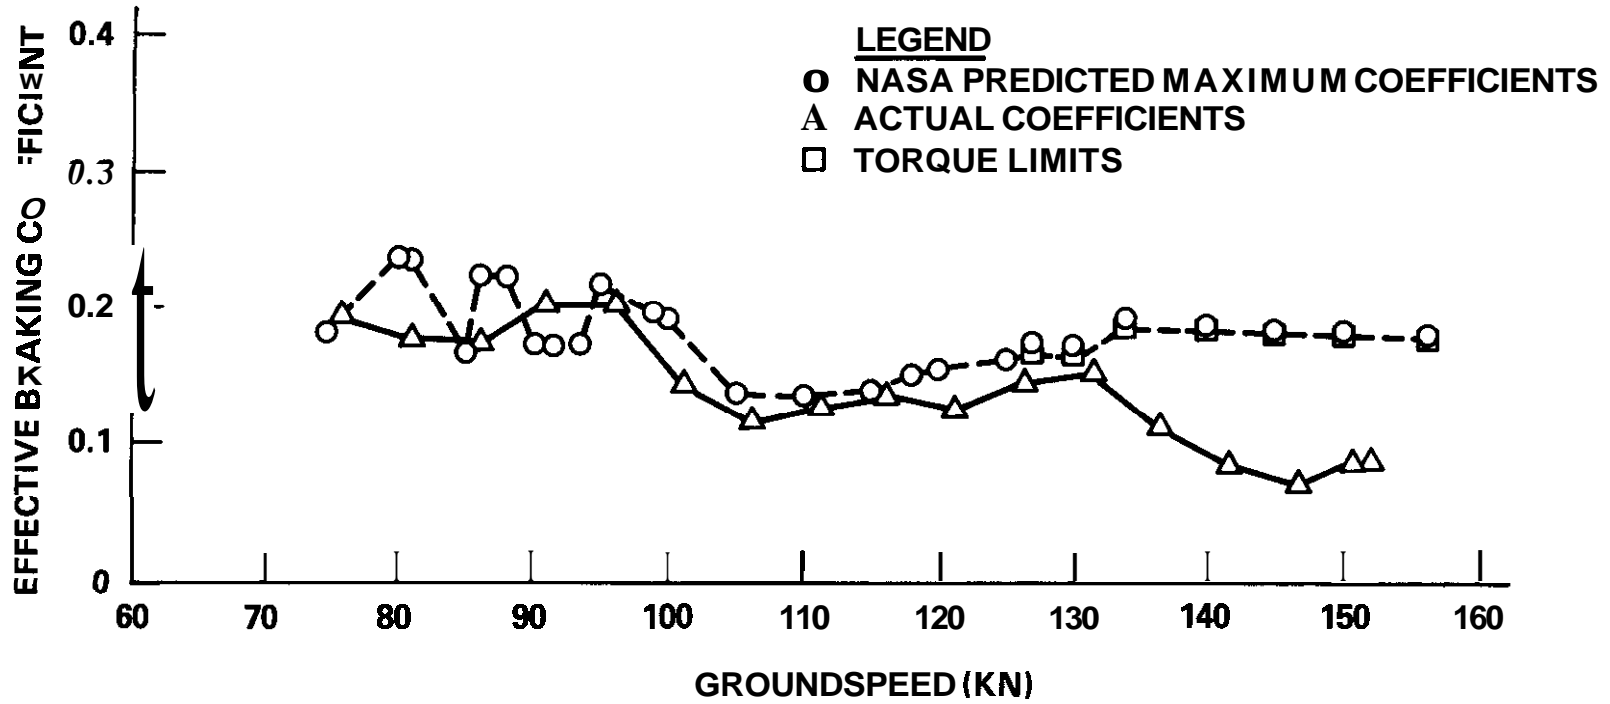
Figure 4. Comparison of actual and predicted maximum braking capabilities.

The actual rejected takeoff braking performance for the Continental DC-10 was calculated using DFDR data and aerodynamic data. These calculations produced a relationship between effective tire-to-pavement frictional coefficients and aircraft groundspeed. When these results were compared to the NASA-predicted maximum braking coefficients over the same speed range, substantial differences were found in the 153 kns to 132 kns groundspeed range, during which the aircraft traveled about 1,200 ft in the initial portion of the takeoff. For groundspeeds between 132 kns and 68 kns (the end of runway speed), the Douglas and NASA braking values substantially agreed, indicating that maximum braking was being achieved over the last 2,250 ft of runway. (See figure 4.) Three possible reasons for the disagreement above 132 kns are: (1) The values predicted by NASA could have been excessive, (2) temporary loss or delay in antiskid system operation, and (3) the crew could have applied less than maximum brake pressure. If the predicted braking levels above 132 kns had been achieved, the aircraft might have stopped intact about 200 ft beyond the departure end of the runway. The Safety Board was not able to quantify the actual amount of braking effort applied by the crew or to accurately determine why the full braking values predicted by the NASA theory were not achieved.
